Project Name: Lagoon Clay Liner Reinforcement
 Location: Blair, Nebraska
 Products: Tenax MS 500 Geogrid
 Application: Clay soil reinforcement
 Owner: Cargill Corn Milling, Inc
 Date: 199?
 Engineer: Terracon Consultants

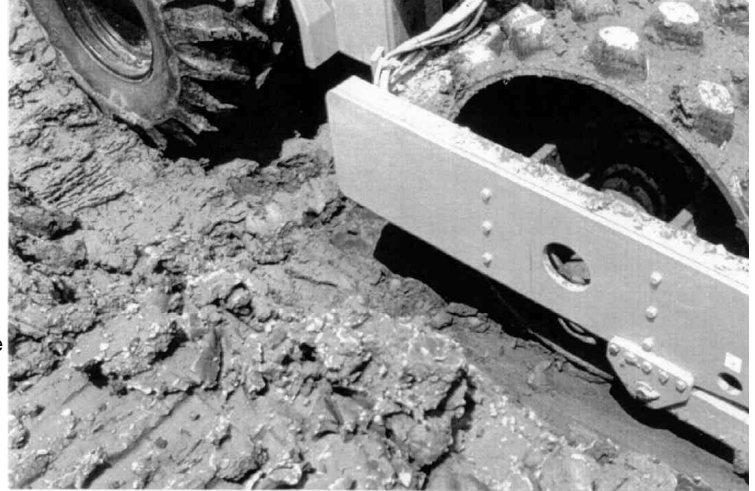
Field tests were conducted to evaluate the proposed solution for weak subgrade stabilization with a multi-layer geogrid. The testing section was at a depth of 2.4 m below the ground surface. The geogrid was placed in an area approximately 4.6 m wide and 30 m long. This area was determined to be one of the most unstable locations at the job site in reference to soil testing. The first 1.8 m of soil was cut by scrapers and the final 0.6 m of excavation was done using a smooth-edged backhoe bucket. When the test depth was reached, the soils were very soft, wet and sensitive to disturbance. Foot traffic on the weak subgrade caused pumping of soil moisture and left deep footprints. The above photo shows a compactor in the area that sank to the drum while attempting to

compact a 0.3 m lift of clay liner material placed on the weak subgrade.

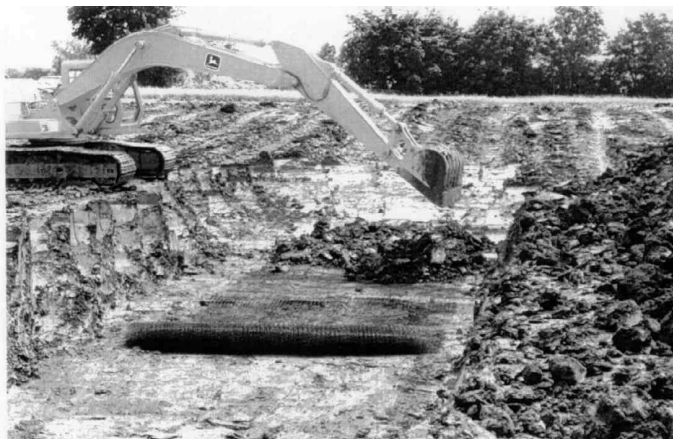
A 0.3 m layer of non-processed on-site clay fill material was spread directly on top of the geogrid. Figure 10 shows the installation of the geogrid. A Caterpillar CP 563 compactor was used to compact the fill soil. This unit has a single drum in front, driven by rubber tires on back. The compactor made 6 passes across the test area. A pass consists of a compactor travel over the area in one direction, the return to the original location was considered the second pass. The test revealed at this point we had an 89% compaction with a water content of 29.3%. After running 4 more passes over the same area, for a total of ten. The test revealed a 97% compaction with 27% water content. To verify this, a second test was done in an adjacent location, still in the test area, this test revealed a 98% compaction with 27% water content. Both tests exceeded 93% required compaction.
